National Inspection Services  
# : 192716 on 12/07/2020  
VIN: 002067 Unit: 6688

Commercial Credit Group, Inc Mark Wenzel  
525 N. Tryon Street Charlotte, NC 28202 USA  
(704) 414-2456

## 2007 KOMATSU HM 300-2

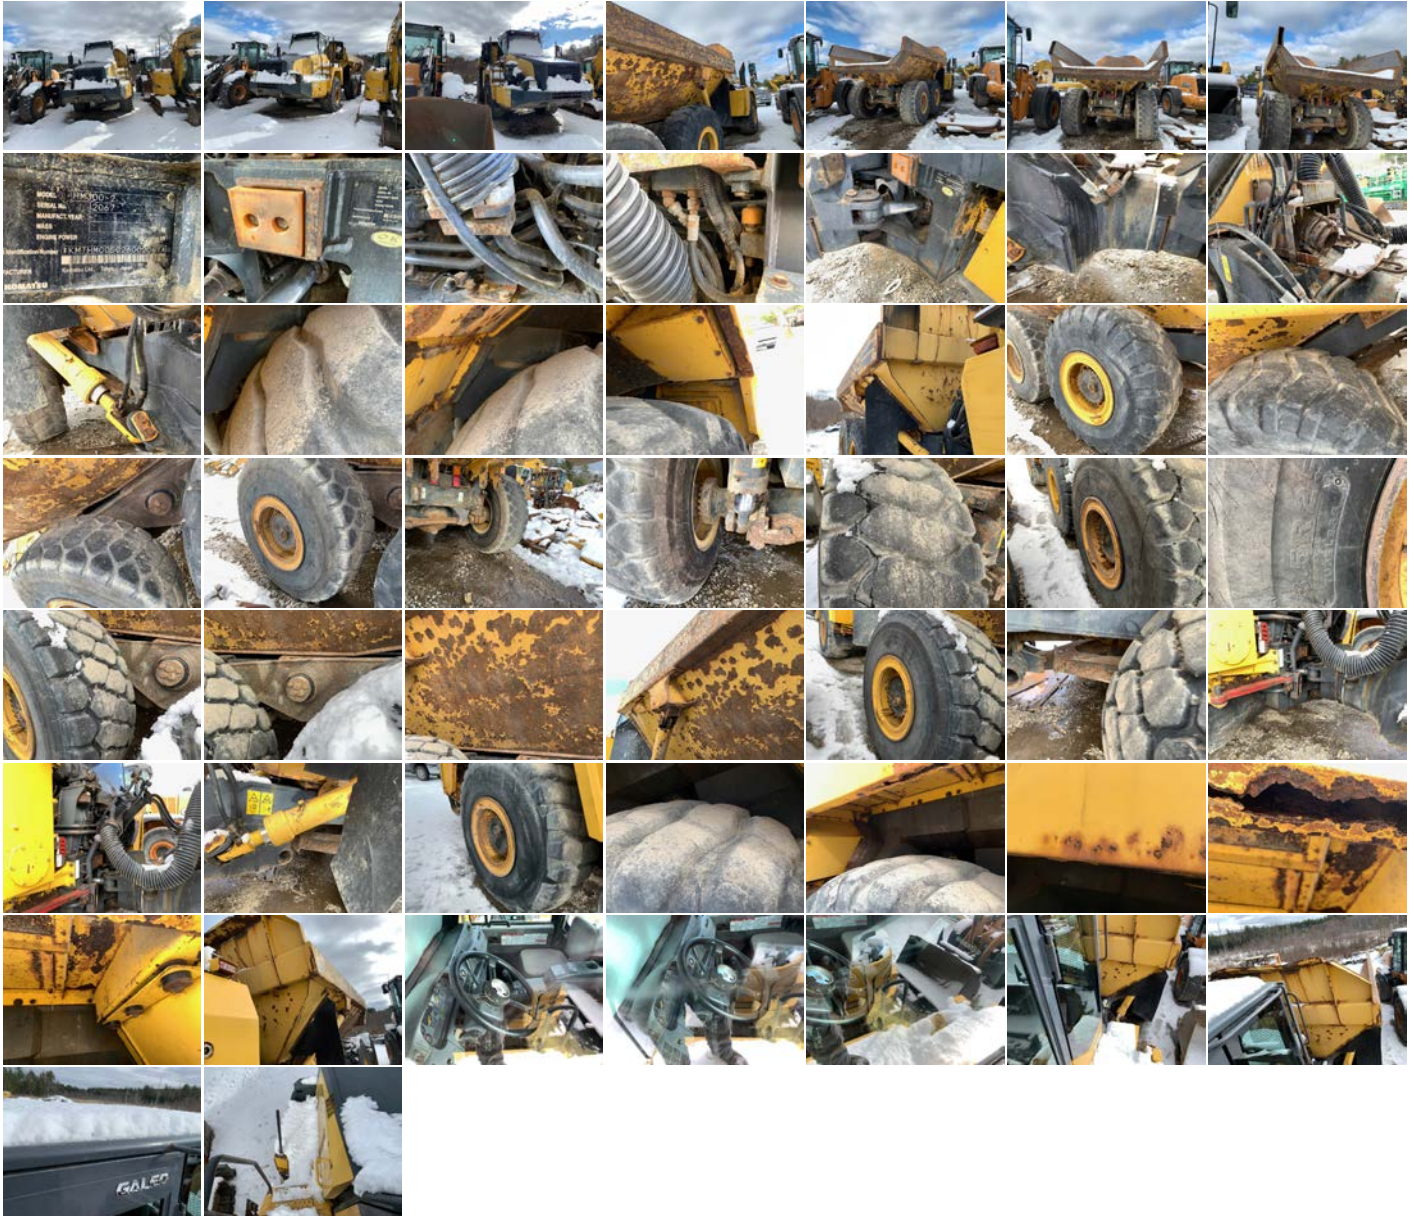
Tires			
Front 23.5 R25	/ 32	/ 32	Rear 23.5 R25
<input type="text"/>	<input type="text"/>	<input type="text"/>	<input type="text"/>
<input type="text"/>	<input type="text"/>	<input type="text"/>	<input type="text"/>
Additional Tire Detail			
tractor tires NOT MEASURED see pics

Wear and Tear Items	
Cab Access Door	frozen in place due to ice and snow, unable to access cab
Paint	Various chips and scratches throughout unit
Dump Body	Rusted throughout
Tires	Multiple tires are weather cracked
Evacuation Chute	Mising cover
Steering Wheel	Missing horn button
