VIN: 1FUJGLDR1HLJF4709

2017 FREIGHTLINER CASCADIA 125

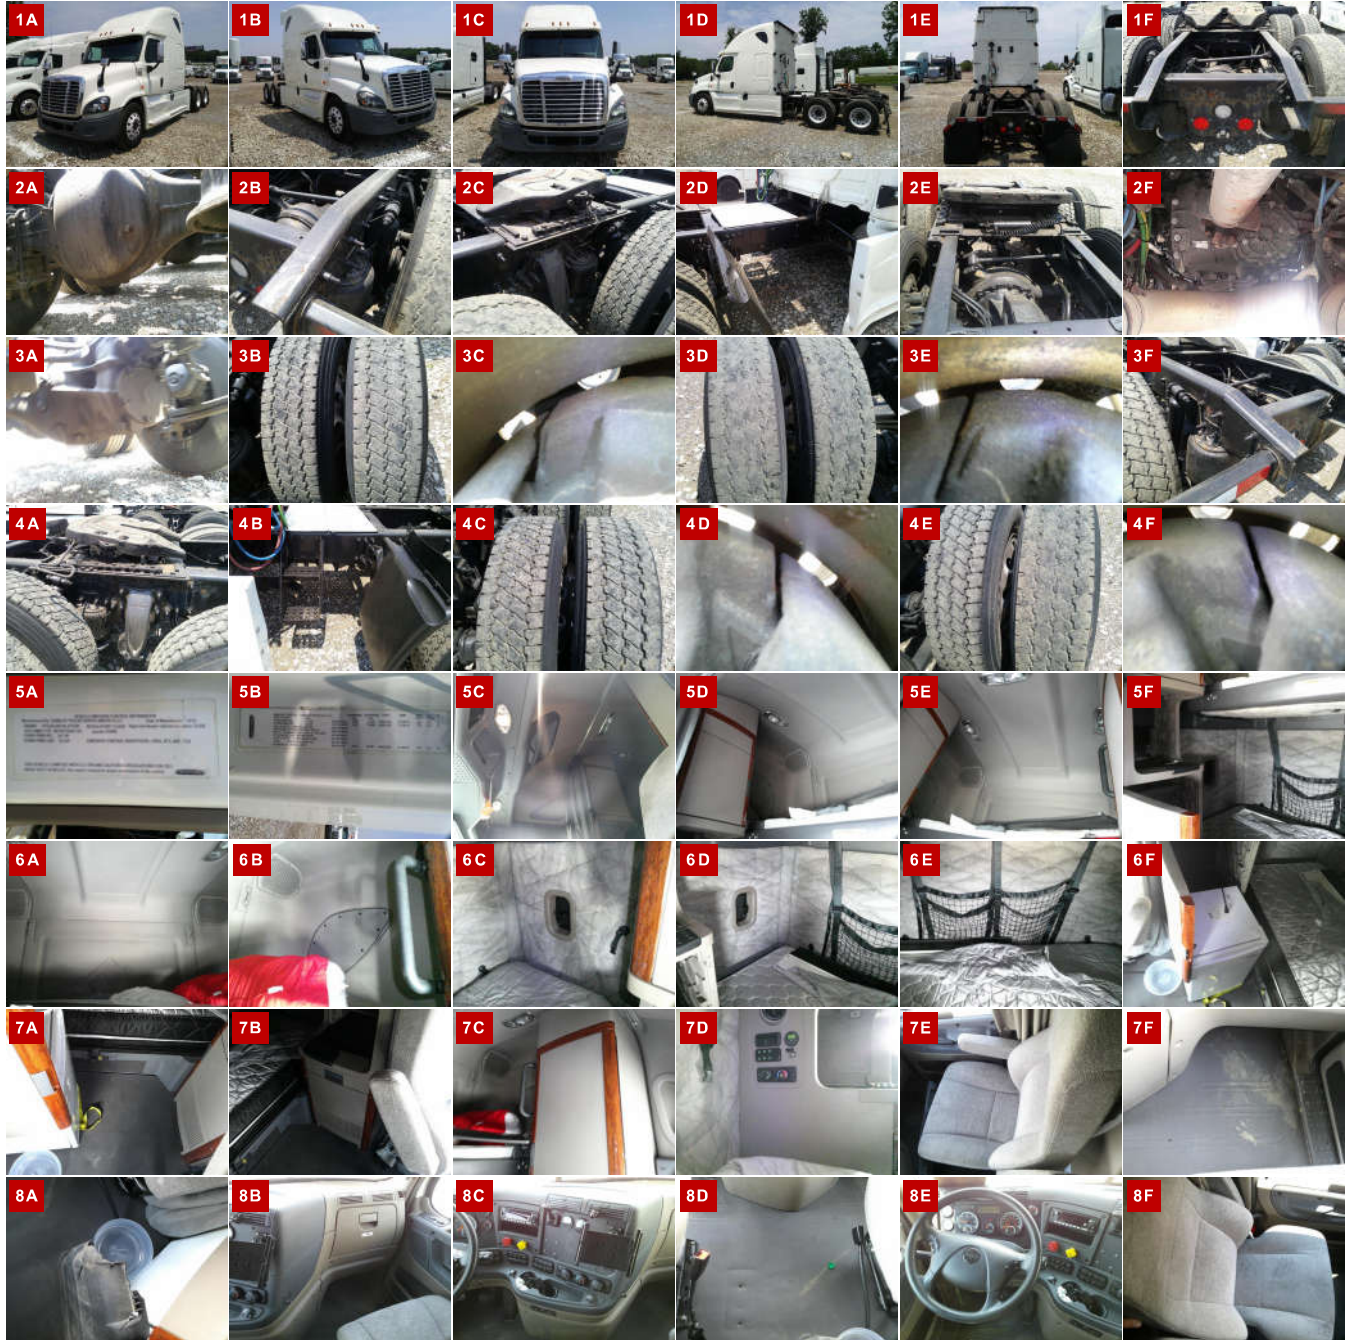
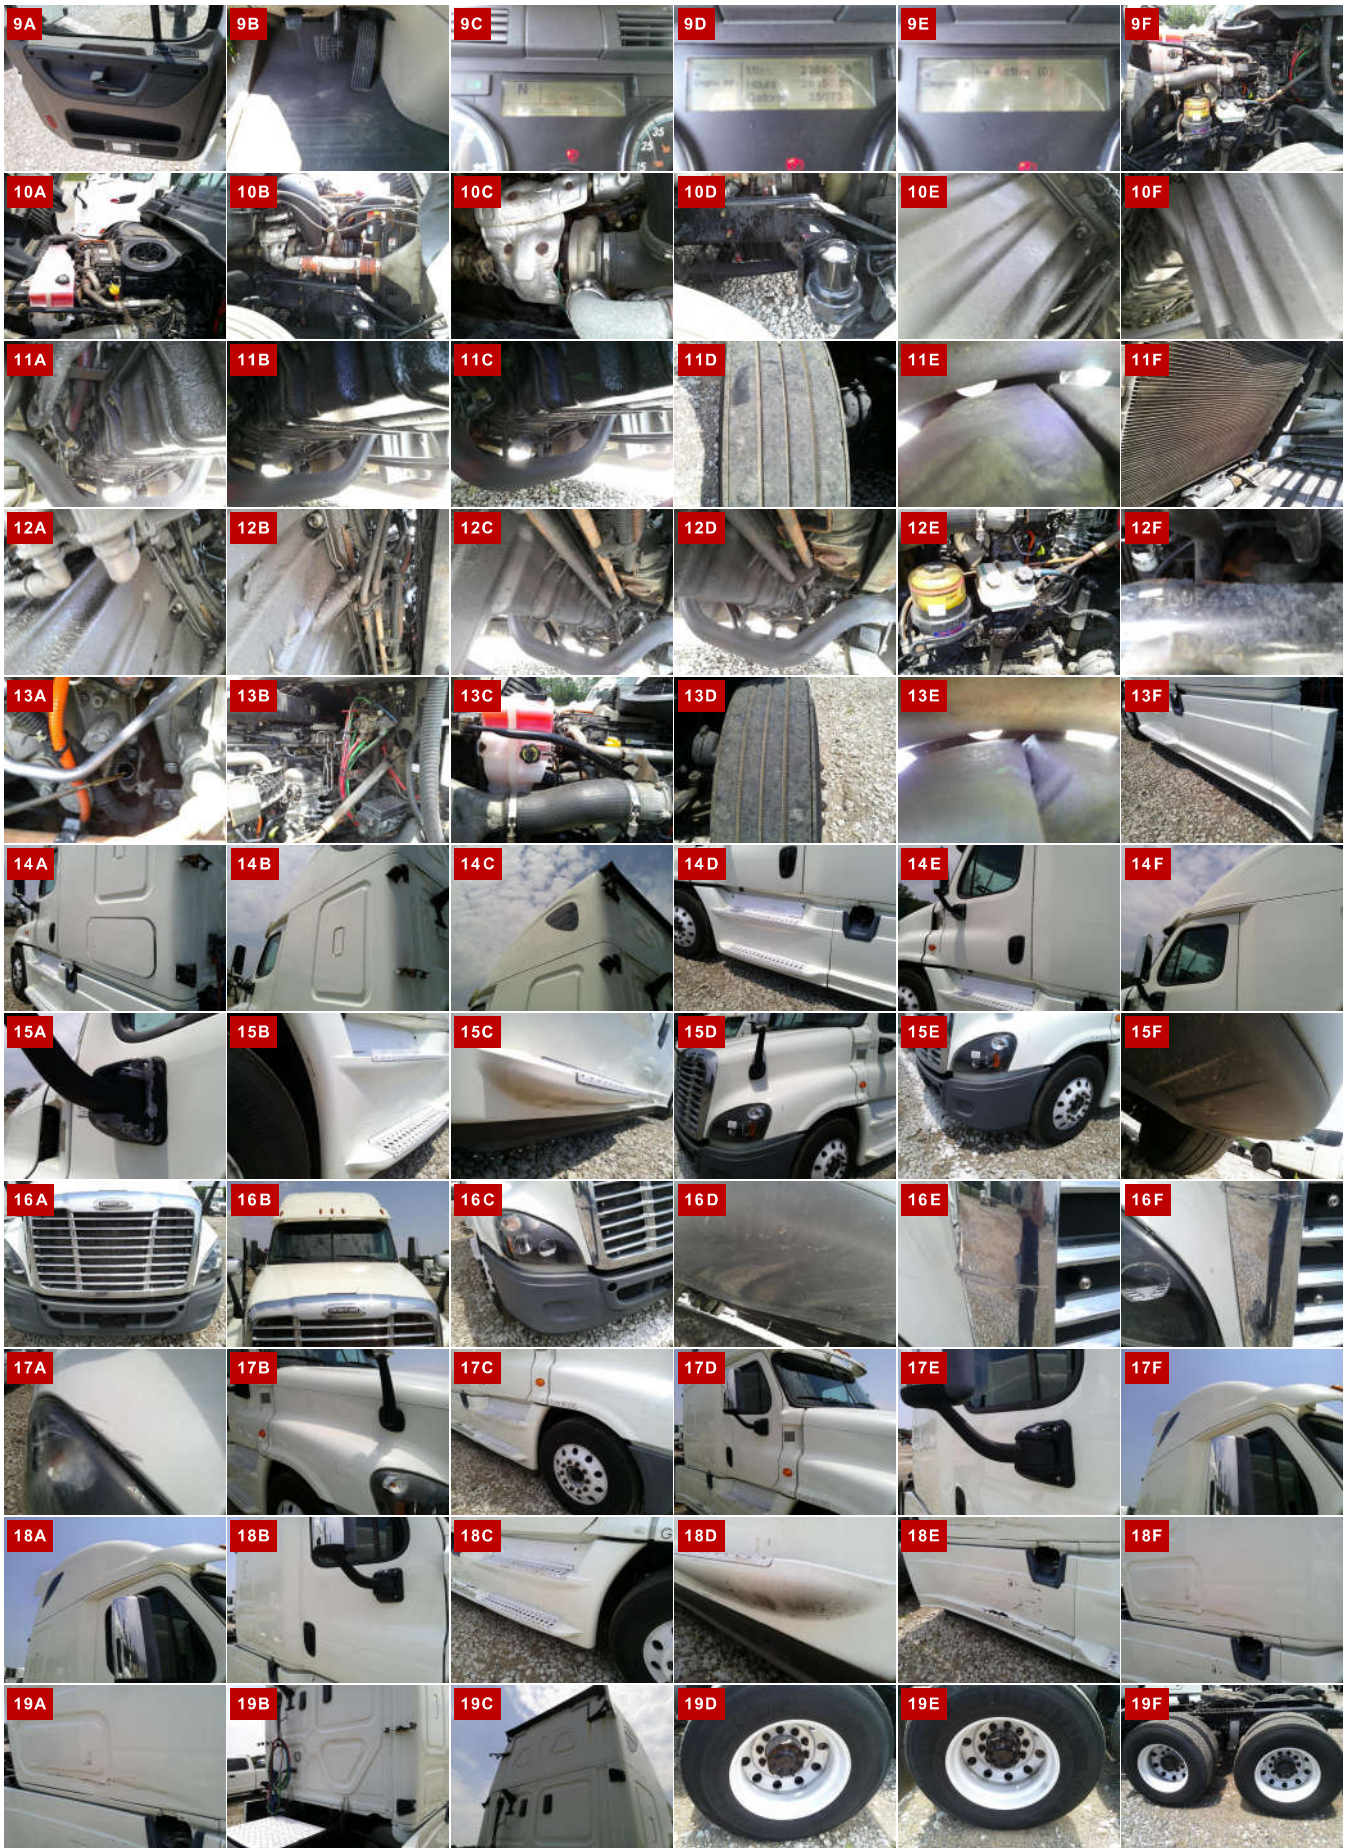
LEAK AT BOTTOM OF BLOCK / OIL PAN.

DIAGNOSTICS	0 ACTIVE, 12 INACTIVE - SEE REPORT
FRONT GRILLE	DAMAGED PLASTIC GRILLE RH SIDE.
FENDER	PASSENGER SIDE LARGE SCRAPE/SCRATCHES ABOVE HEAD LIGHT
PASSENGER SIDE EXTERIOR	DAMAGED FAIRING REAR RH SIDE. HEAVY DAMAGE EXTERIOR SLEEPER RH SIDE.
INTERIOR	DIRTY
TIRES	7 BELOW 10/32'S
HUB COVER	MISSING
CAB EXTENDERS	MISSING BOTH SIDES
