National Inspection Services  
# : 171368 on 08/05/2019  
VIN: 3HSDJAPR3GN222792 Unit: 1119

## 2016 INTERNATIONAL PROSTAR

## 2016 INTERNATIONAL PROSTAR PHOTOS

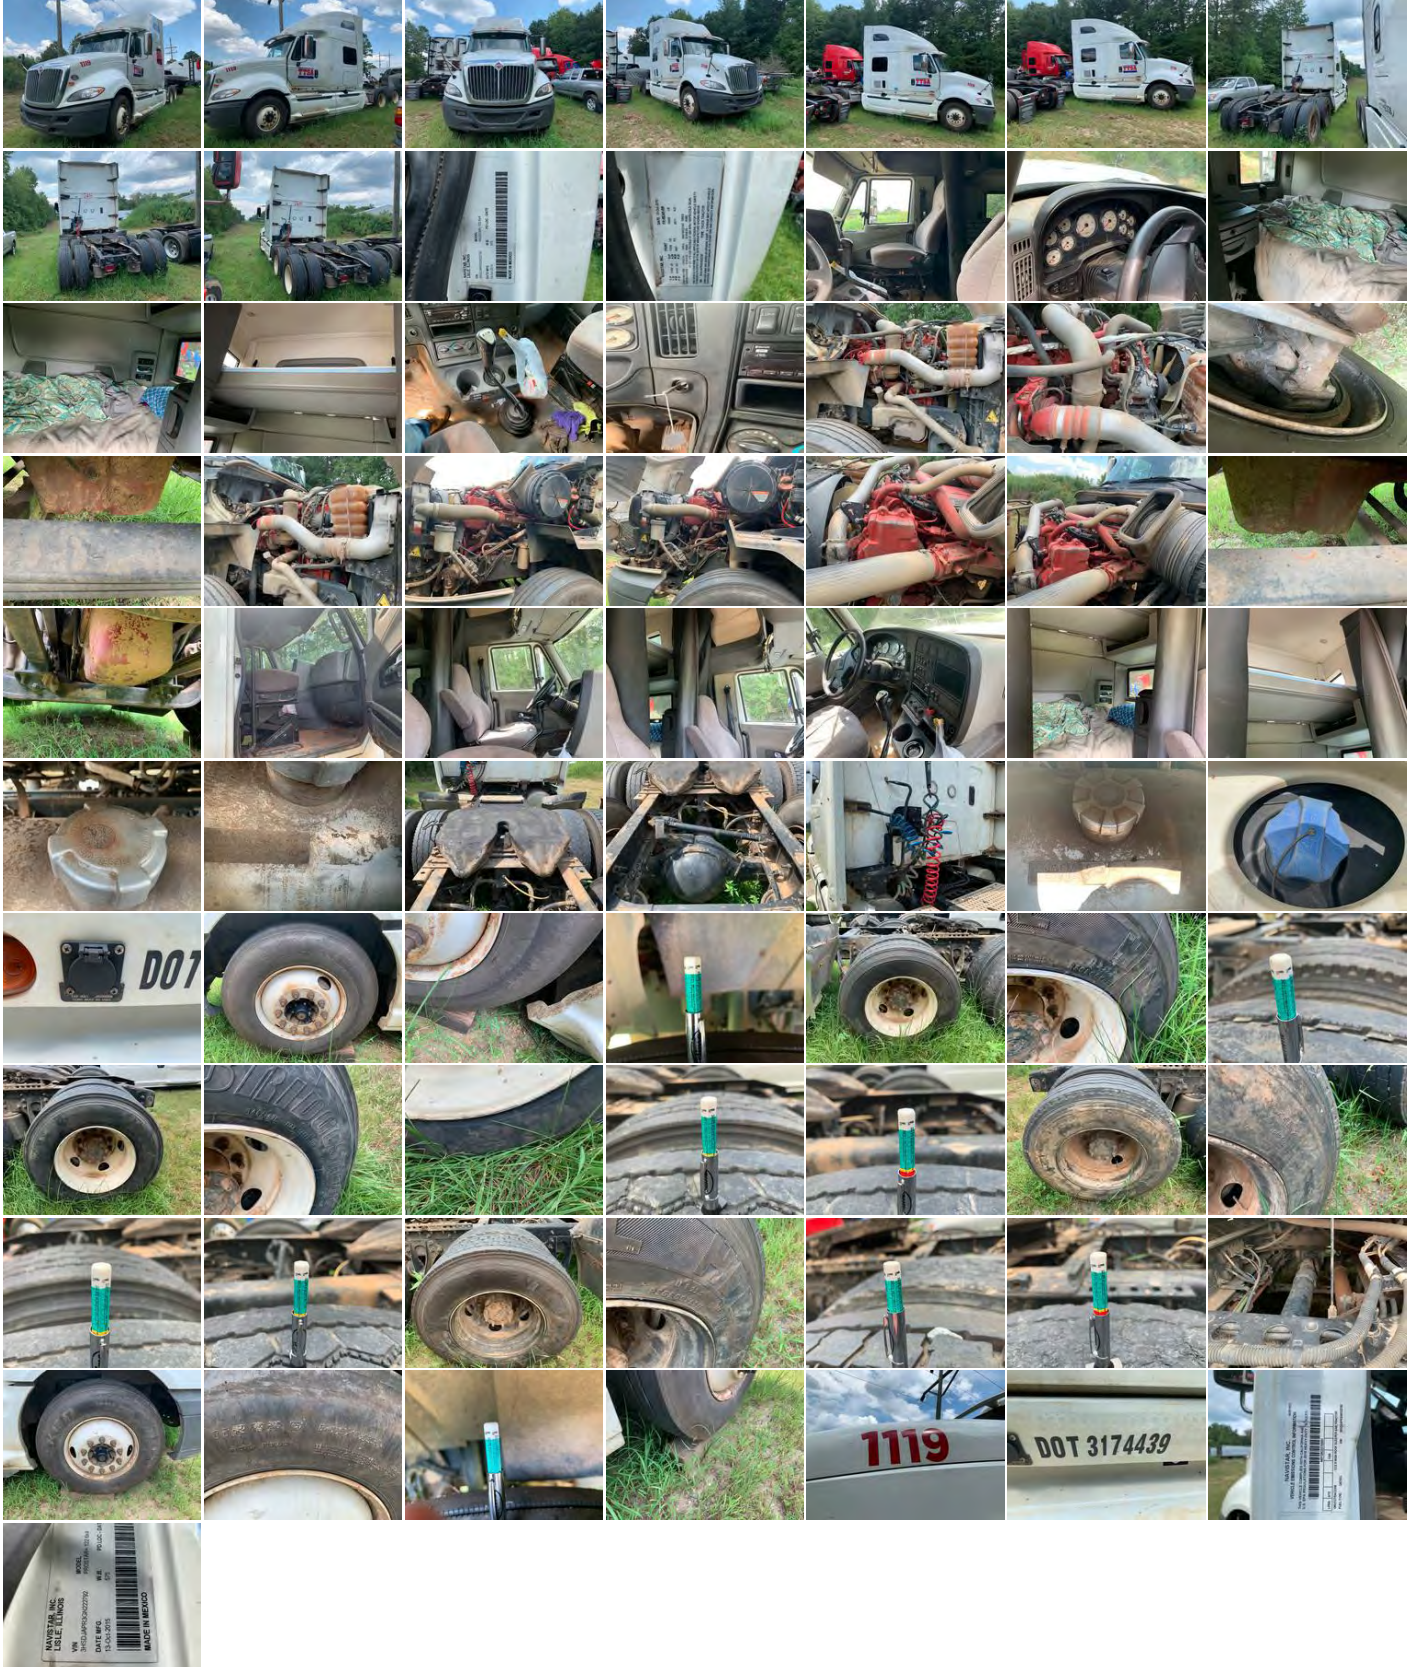
Wear and Tear Items	
Visor	Cracked
Front Bumper	Scratched and small rock screen damaged
Small Dents	Small dents on the corner of the cab rear.
Tires	8 below terms
Cab extenders	Damaged bboth sides
Rear of cab	Cracked / damaged
1/4 fenders	Damaged
Mud flaps	Missing
Paint	Various chips and scratches
Interior	Soiled
