National Inspection Services  
# : 174457 on 11/01/2019  
VIN: 1HTGSSHT8DJ125396

## 2013 INTERNATIONAL 7600

## 2013 INTERNATIONAL 7600 PHOTOS

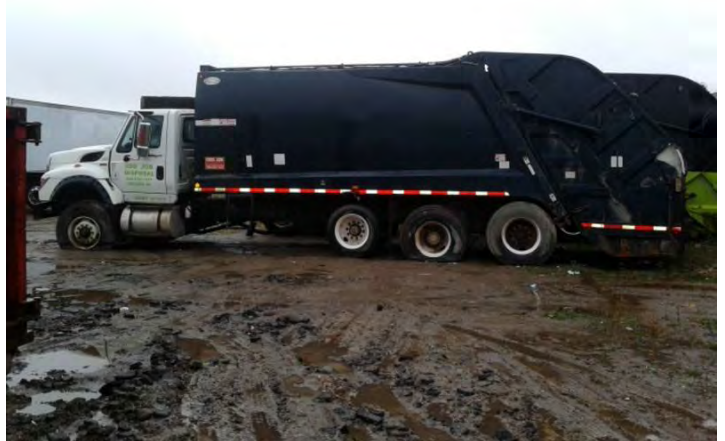
### Inspection Photos

General Observations													
Oil Milky?	No	Oil Leaks?	Yes	Water Leaks?	No	Oil in Coolant?	No	Clutch Play?	NA	Starts?	No	Drives?	No
Safety / Operational Observations													
Lights Work?	See Notes	Wipers Work?	See Notes	Gauges Work?	See Notes	City Horn Works?	See Notes	Air Horn Works?	See Notes				
Additional Observation Detail													
Unit will not start. Leak at oil pan, front cover and both sides of block.

Wear and Tear Items	
tires	left steer, LFO, RRI, RRO tires are flat, missing inner tires
interior	dirty, seats torn
fenders	scraped
bumper	dented, bent
cab	dents
steps	dented, bent, peeling, rusty
paint	chips at doors, fenders, bumper, hood, skirts, fairings, cab, frame, axles, packer box
packer	water inside, rear steps bent
mirror	left side mount damaged
rust
