National Inspection Services
: 165494 on 04/17/2019
VIN: 1RNF48A26GR038493

2016 REITNOUER FLATBED

2016 REITNOUER FLATBED PHOTOS

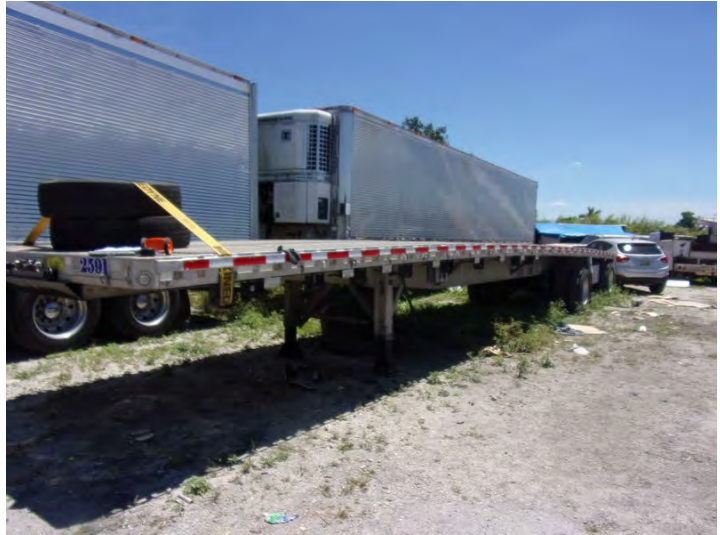
FLATBED Specifications	
Axles	Tandem 23,000 Front / 23,000 Rear
Spread Axle	Yes
Frame Type	Aluminum
Suspension	Air Ride
Tire Size F	295/75R22.5
Tire Size R	295/75R22.5
Wheels	Aluminum
Exterior	102"W 48'L

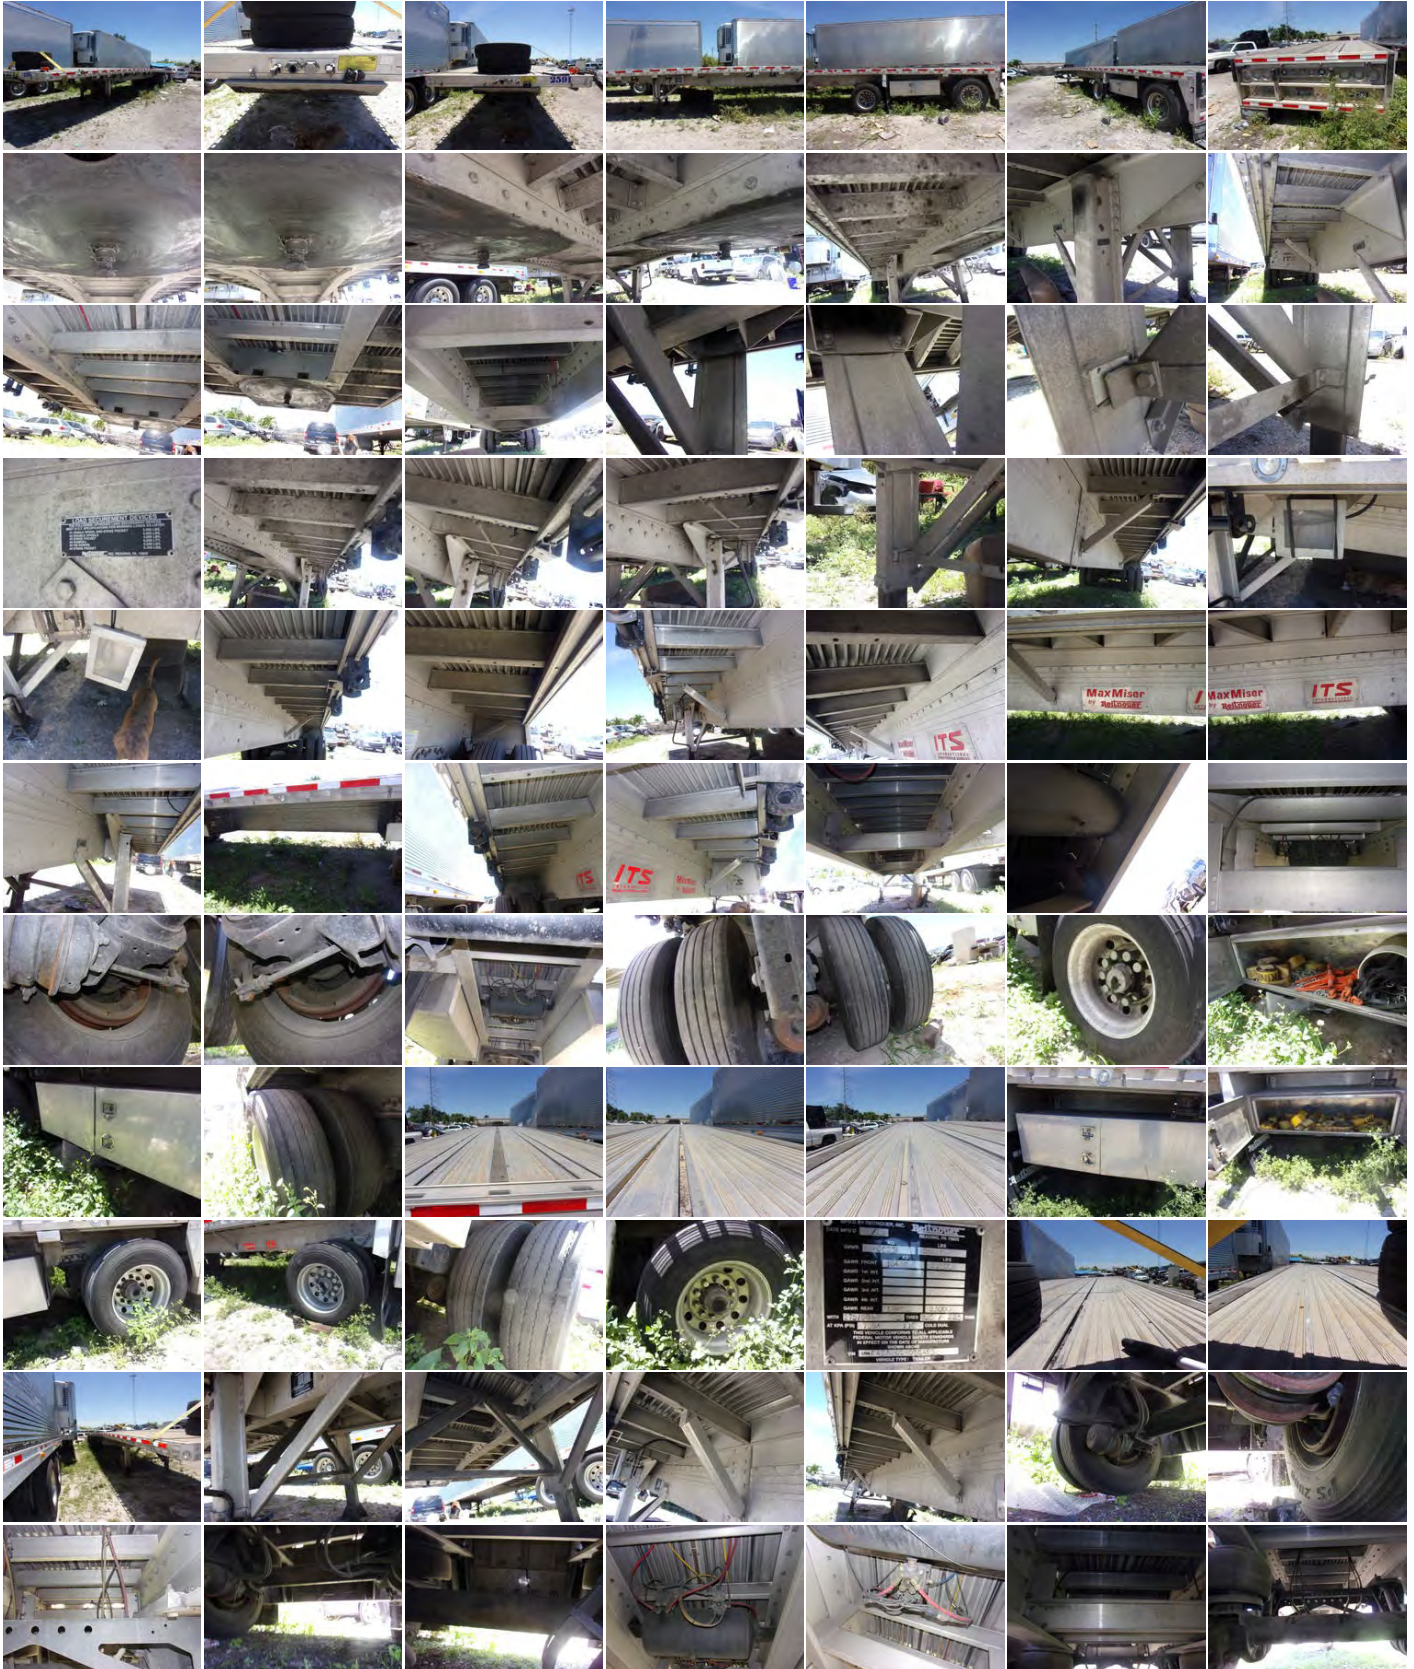
Wear and Tear Items	
landing gear	R/S bracket to leg, weld is broke, bracket is separated from leg
air control box	control box for air leveling is broken off of bracket
wood floor inserts	showing some weathering deterioration
tires	8 measure below 10/32, rear axle tires show more wear
