National Inspection Services
 # : 174467 on 10/07/2019
 VIN: 3HSCXAPRXHN570570 Unit: 1096

2017 INTERNATIONAL LONESTAR

Inspection Photos

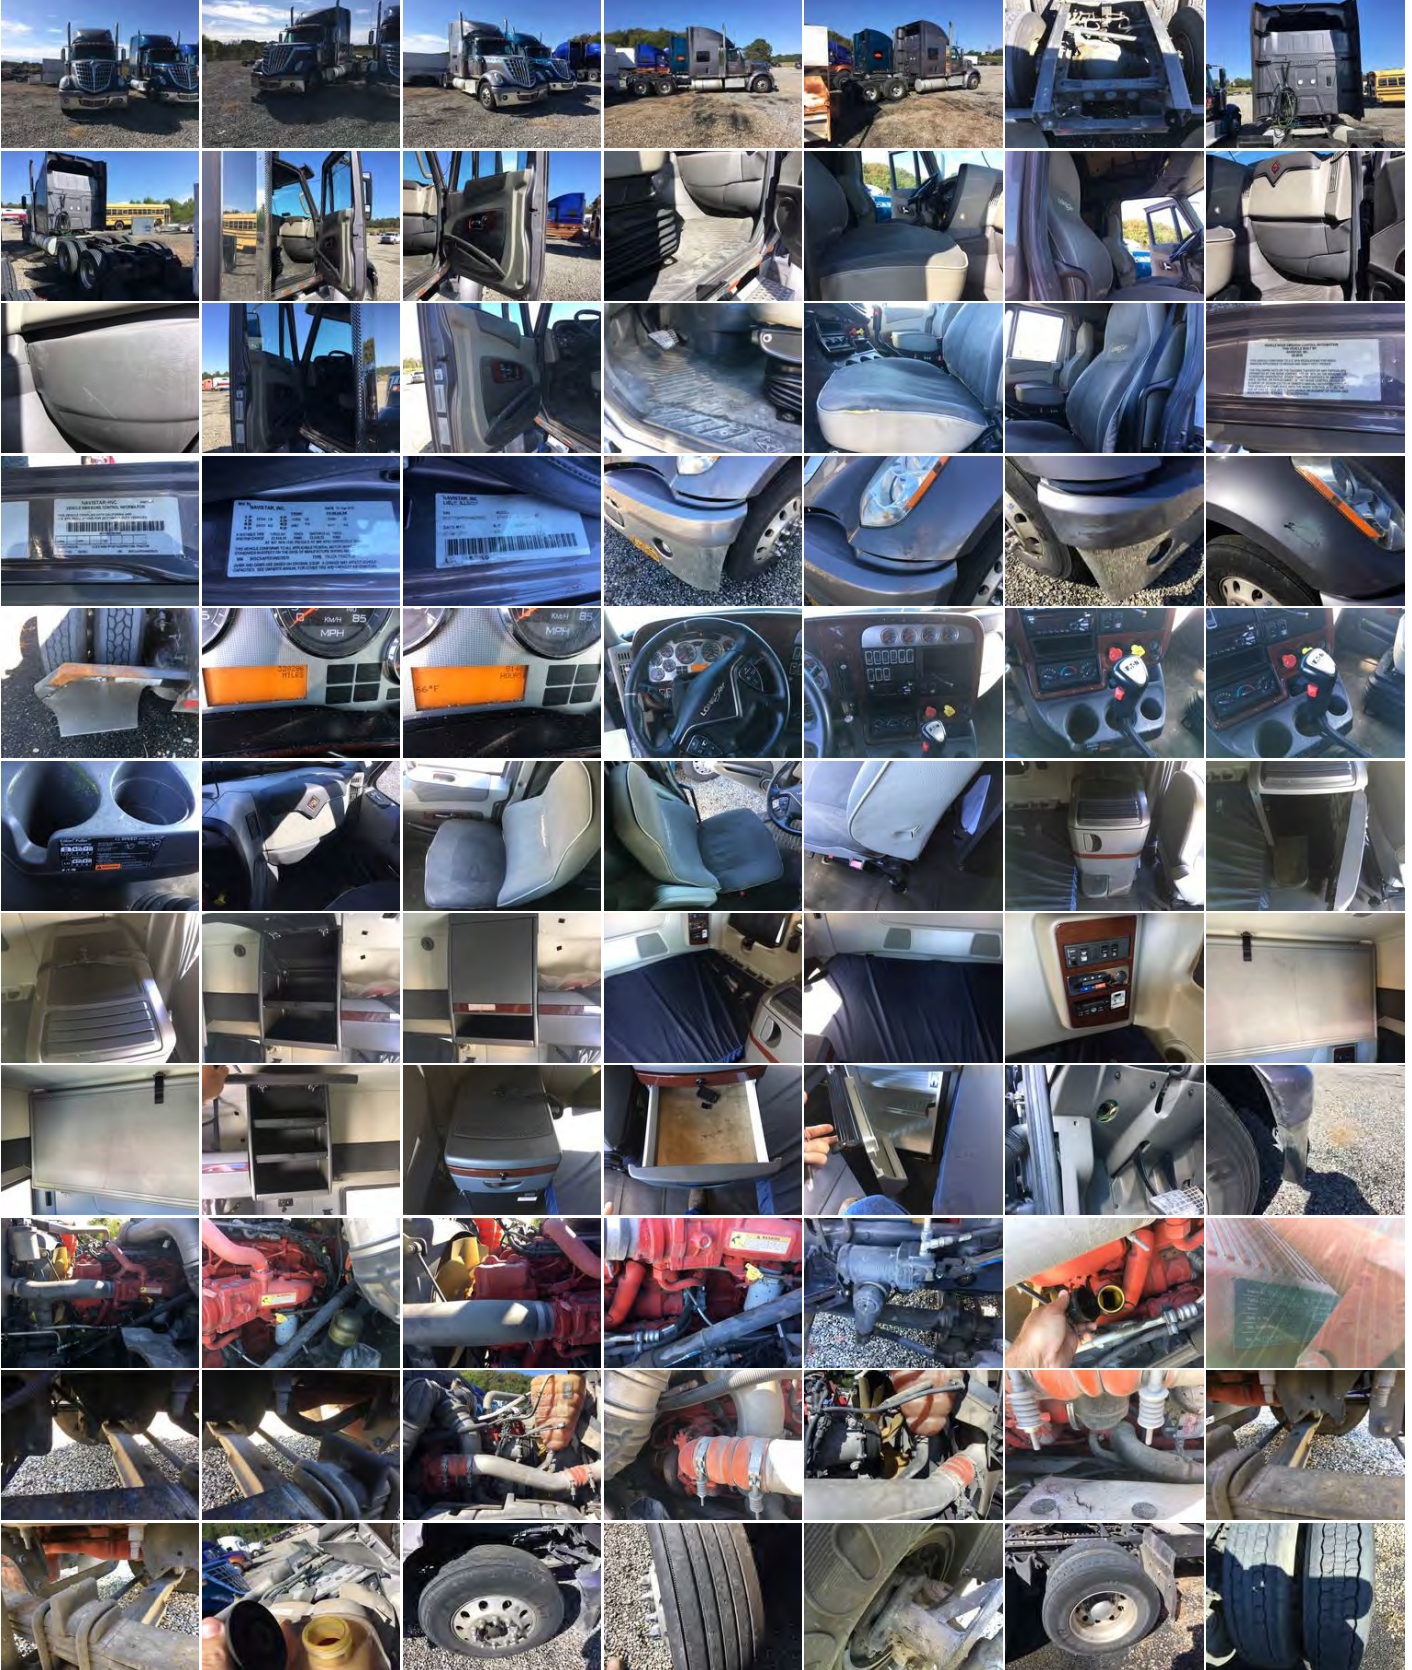
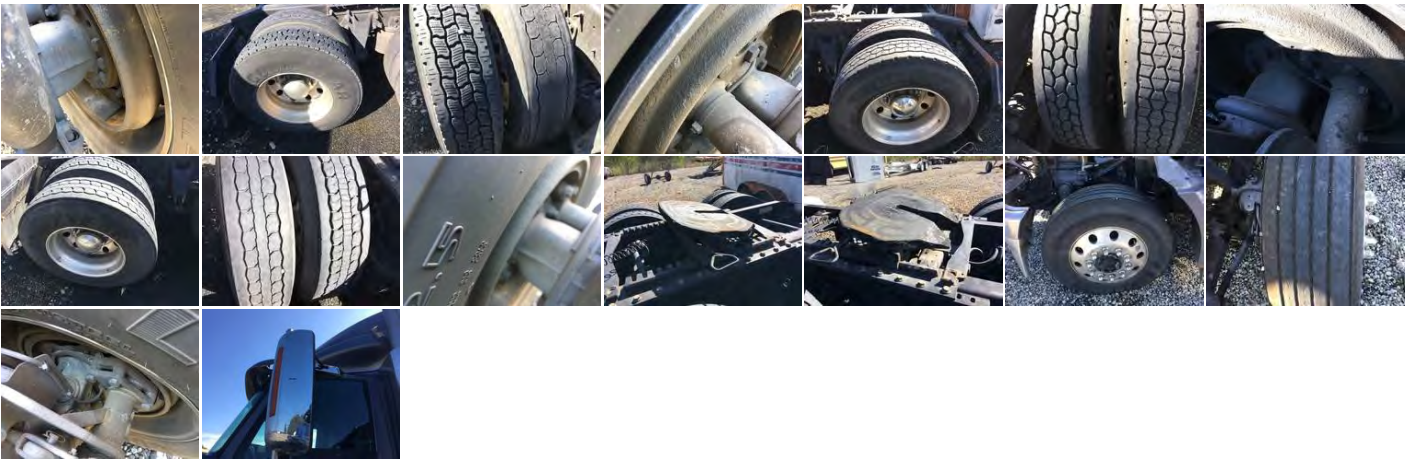
2017 INTERNATIONAL LONESTAR PHOTOS

Wear and Tear Items	
INTERIOR	DATA PLUG FELL DOWN BEHIND KICK PANEL WHEN UNHOOKING DATA READER
DASH	SCRATCHED
BUMPER	DAMAGED
HOOD	PAINT PEELING
MUD FLAP HANGERS	RUSTED
INTERIOR	SOILED
SEATS	RIGHT AND LEFT SEATS STAINED AND WORN, RIGHT SIDE DAMAGED ARM REST MISSING
WINDSHIELD	CHIPPED
MIRROR	LEFT SIDE SCRATCHED
TIRES	2 BELOW TERMS
PAINT	VARIOUS CHIPS AND SCRATCHES
