VIN: 3HSDJAPR8GN278579

2016 INTERNATIONAL PROSTAR

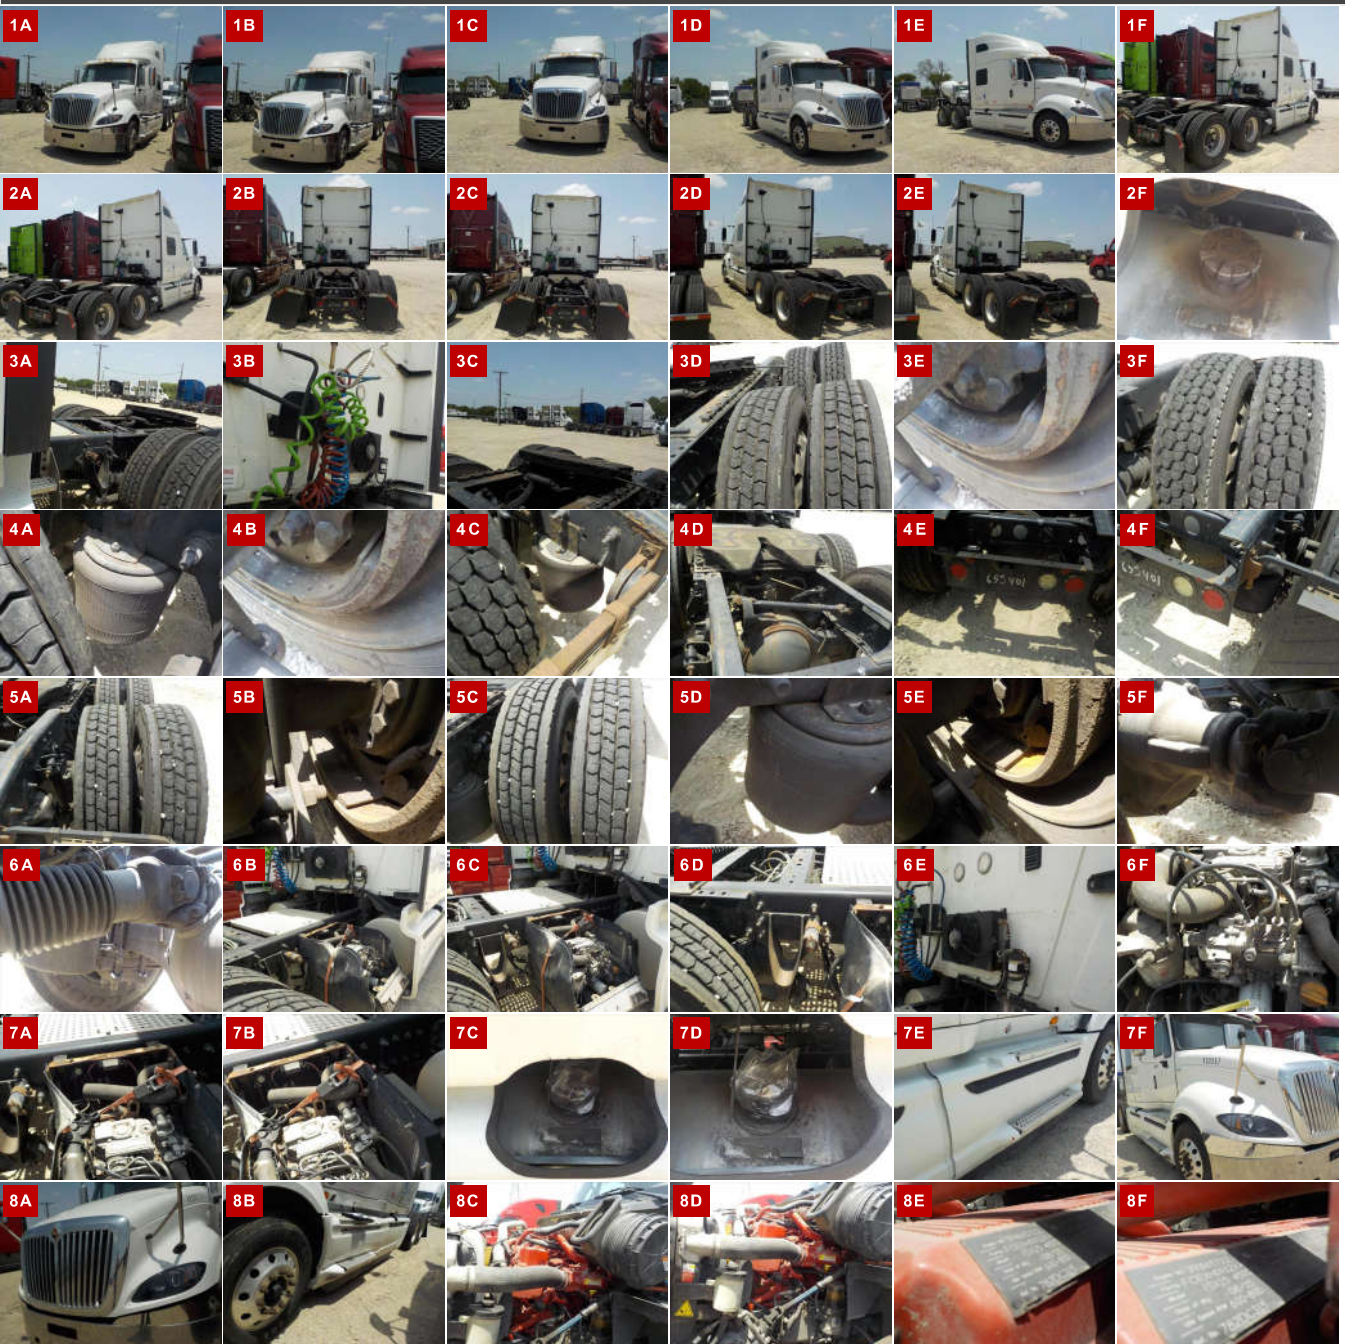
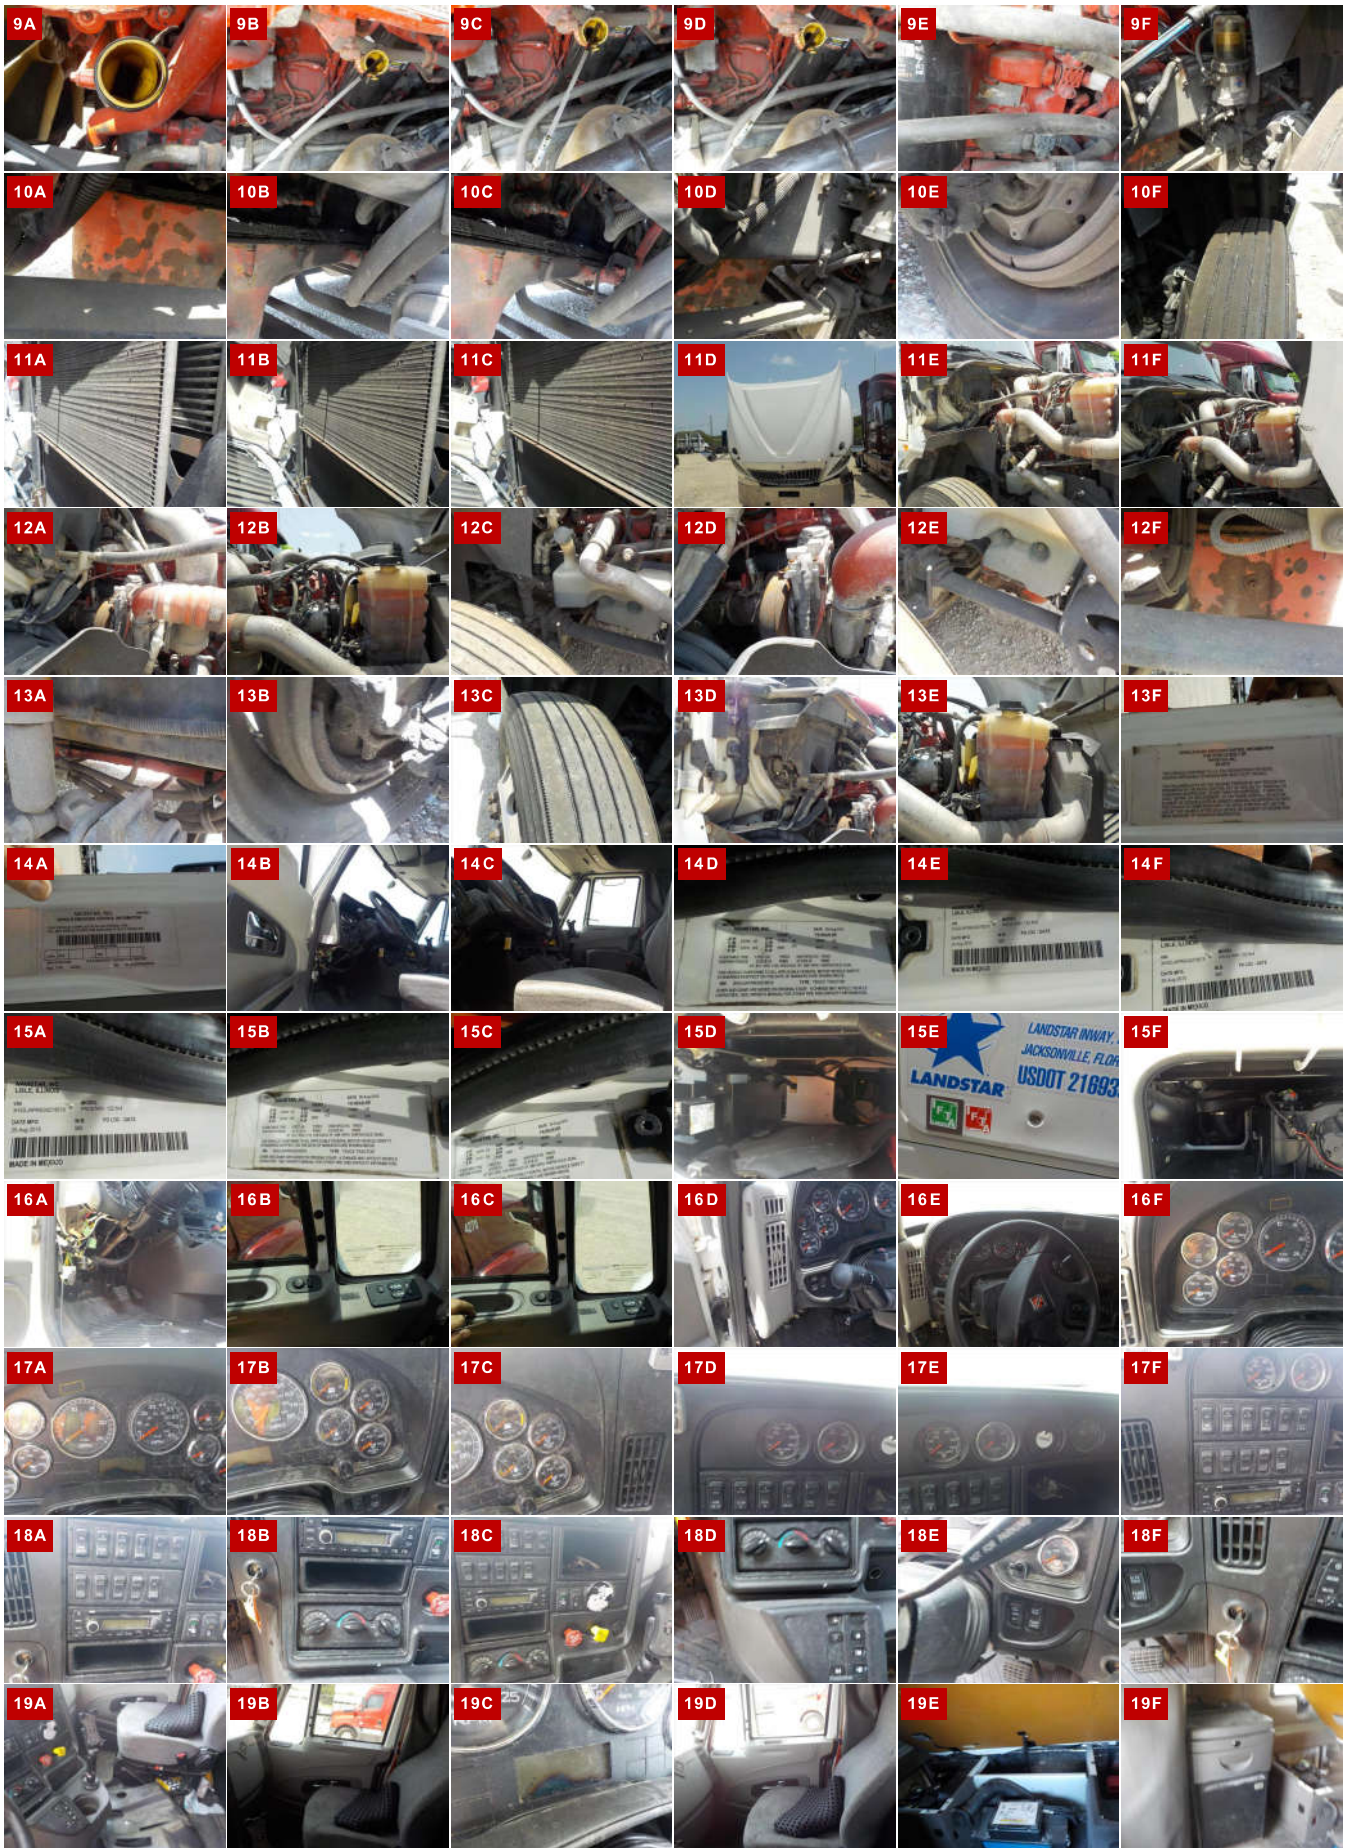
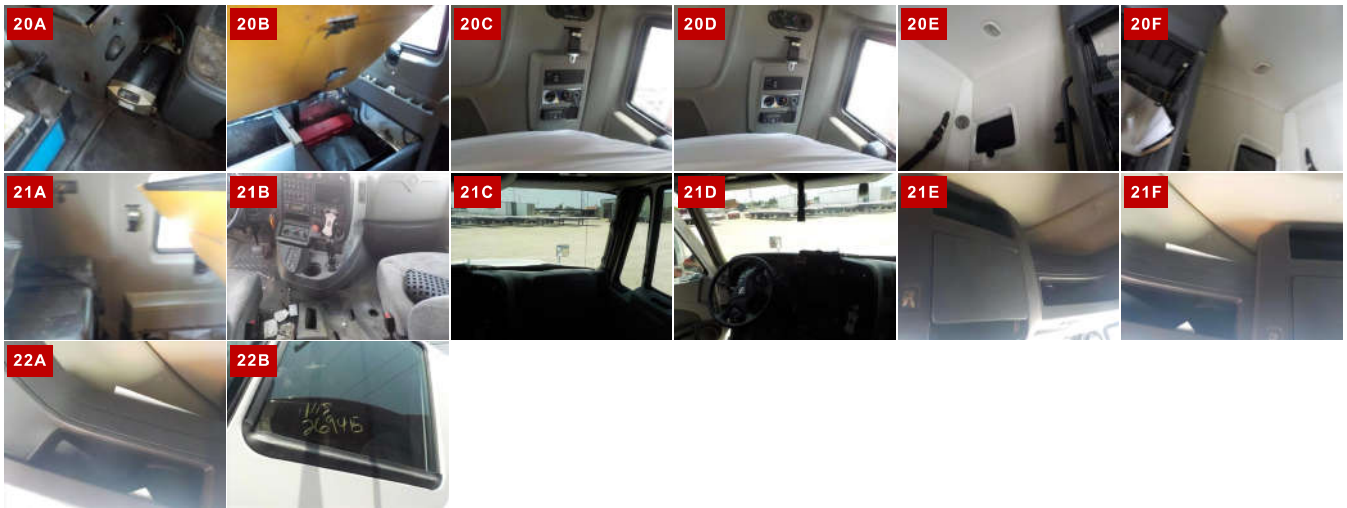
REPORT PHOTOS

SEE PAGE AT BOTTOM OF BLOCK / OIL PAN.

BATTERIES	WEAK - NOT HOLDING CHARGE, WILL NOT START
PAINT	VARIOUS CHIPS AND SCRATCHES
SEATS	SHOWING SIGNS OF WEAR
APU	MISSING TOP COVER, CABINET BENT - INOPERATIVE
BAGGAGE DOOR	LEFT SIDE WILL NOT LATCH
1/4 FENDERS	MISSING AND/OR REMOVED
FUEL TANK	RIGHT SIDE MISSING CAP
INTERIOR	NEEDS CLEANING AND DETAIL
