Commercial Credit Group, Inc (Mark Wenzel)
525 N Tryon Street, Charlotte, NC 28202 USA
(704) 414-2456

VIN: 1M1AN4GY4KM010079

2019 MACK ANTHEM

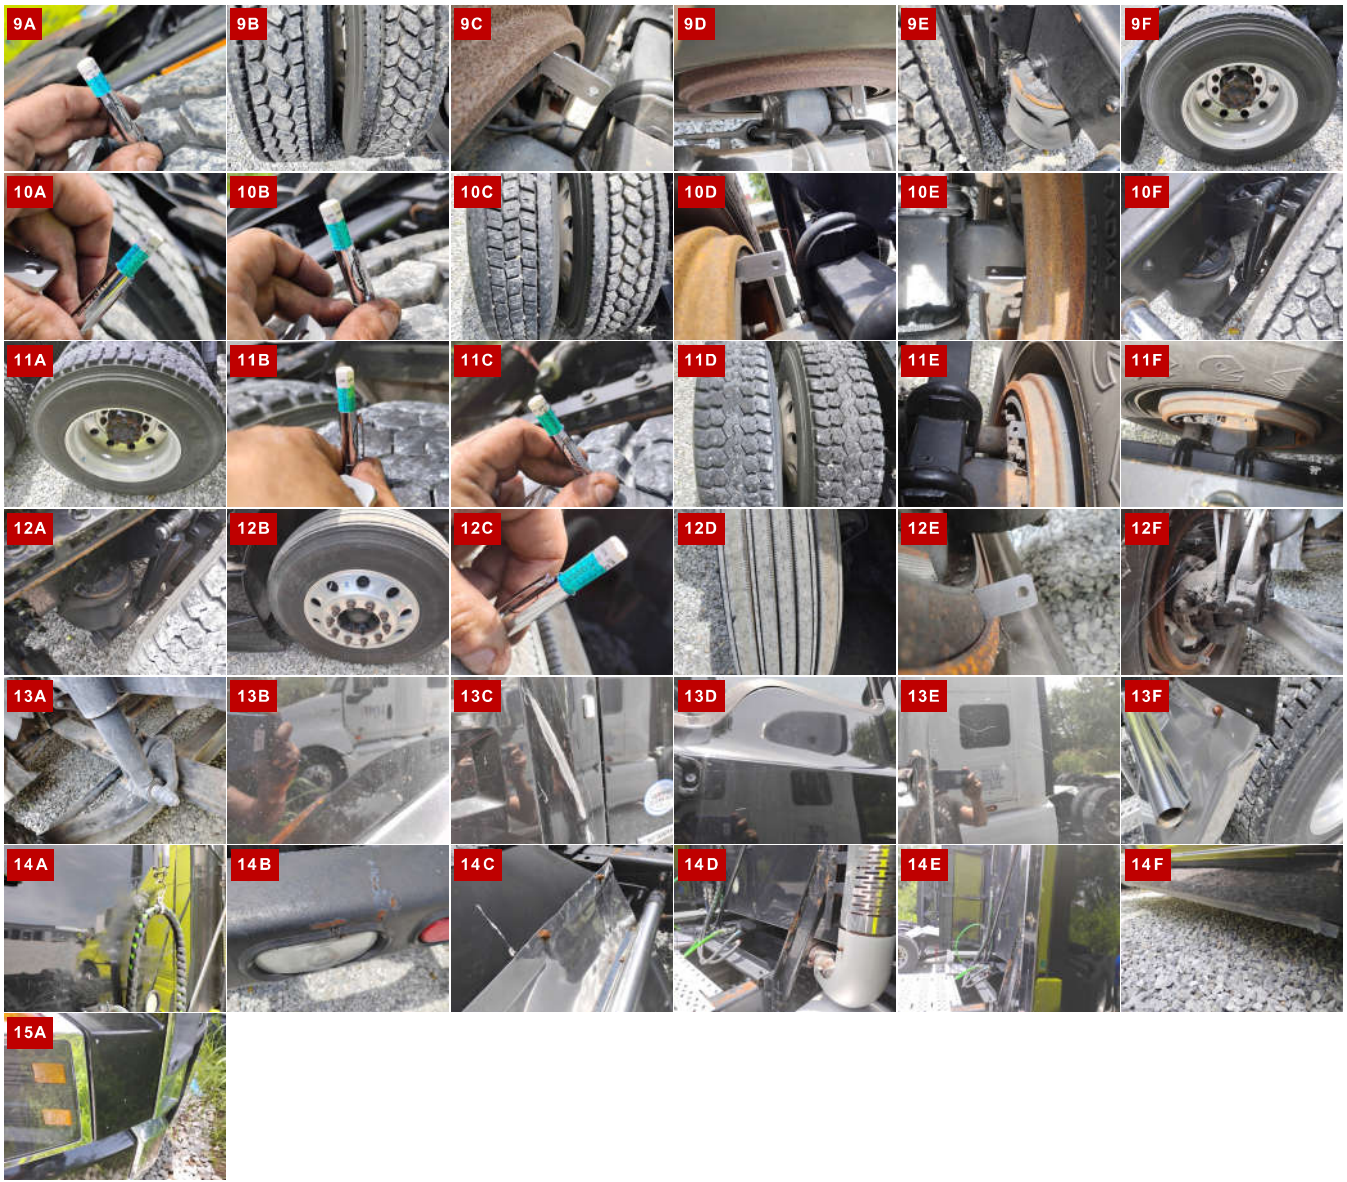
REPORT PHOTOS

DIAGNOSTICS	NO KEY COULD NOT RUN OR CHECK ALL FUNCTIONS
HOOD	PAINT CHIPS AROUND HEADLIGHTS AND GRILLE
RUST	RUST ON TAIL LIGHT AND EXHAUST BRACKETS.
QUARTER FENDERS	BOTH ARE BENT
CAB	REAR OF CAB SCUFFED FROM AIR HOSES
FAIRING	MISSING BOTH LOWER RUBBER SKIRTS BOTTOM PIECE OF FAIRING.
SCRATCHES	SCRATCHES ON FENDERS, SIDE, AND DOOR.
