**Commercial Credit Group, Inc (Mark Wenzel)**  
525 N Tryon Street, Charlotte, NC 28202 USA  
(704) 414-2456

VIN: 5PVNJ8JV3J4S66862  
PO #: 15090

**2018 HINO 268**

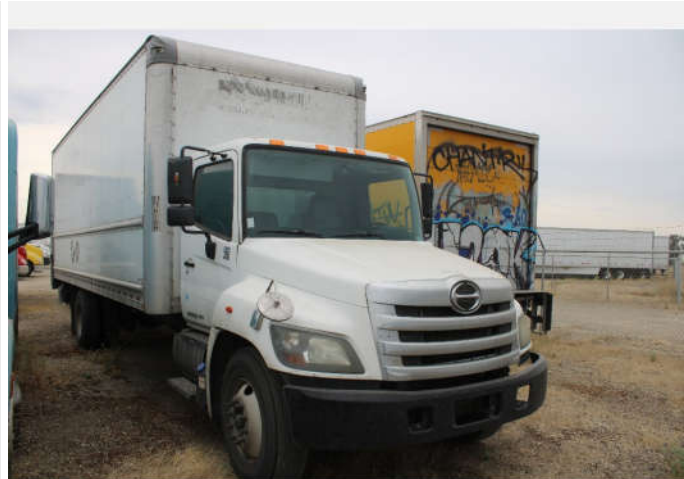
NOTES / DESCRIPTION
DEAD BATTERIES, UNABLE TO START AND TEST.

ENGINE	NO START, NO ONE ON IMPOUND LOT TO TRY AND JUMPSTART. THIS WAS REPORTED TO THE CUSTOMER.
BOX	RIGHT SIDE SCRAPES & SCRATHES.
BATTERY COVER	MISSING.
MIRRORS	HOOD MIRROR IS BENT
STEERING WHEEL	SURFACE IS WORN.
